Executive Summary

Airflow Measurement System Case Study

Juvenile Detention Facility | Madera, CA

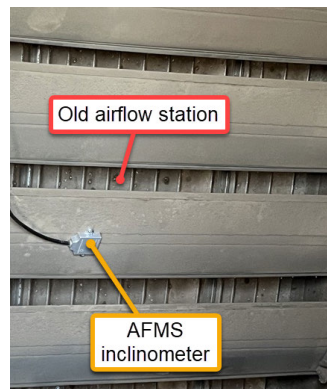
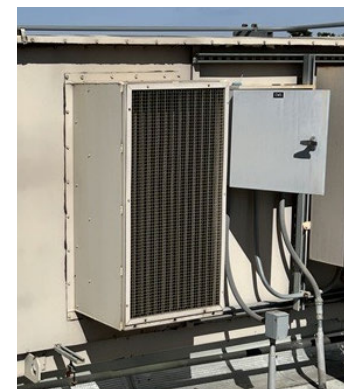
Left: An outdated airflow station (seen through the damper) clogged with dirt. Right: Modifications to the units were required to mount the old airflow stations externally.

Outdated airflow stations posed challenges related to accuracy, maintenance, and reliability. The stations utilized differential pressure sensors with air strainers intended to reduce turbulence. They were prone to clogging with dirt and debris, compromising their performance, hindering accurate airflow measurements, and requiring frequent maintenance. The airflow stations also required modifications to the AHUs upon installation, leading to disruptions and compromising overall efficiency. Madera County needed an unobtrusive solution that could provide a high level of accuracy while requiring little to no maintenance.

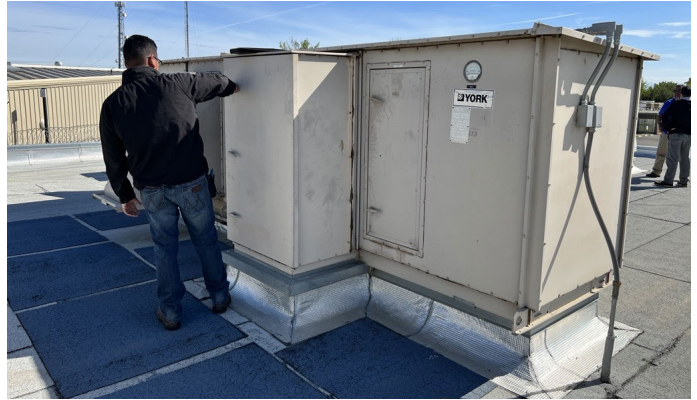
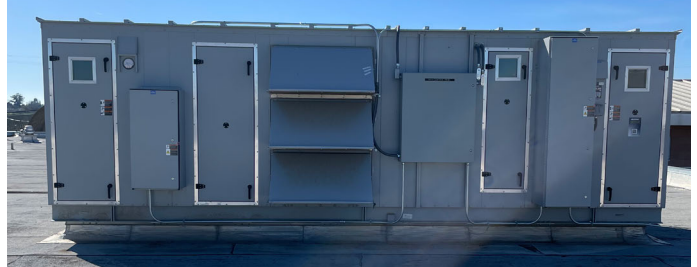
The versatile AFMS was easily installed in five retrofits (such as above) and one new unit (below).

Installation on six AHUs, including five retrofits and one new unit, showcased the versatility and effectiveness of the AFMS in diverse situations.

The AFMS inclinometer was strategically mounted on the units' outside air dampers, while airflow measurement probes were installed on supply fans when needed. To maintain the existing BAS, data integration was achieved through MS/TP.

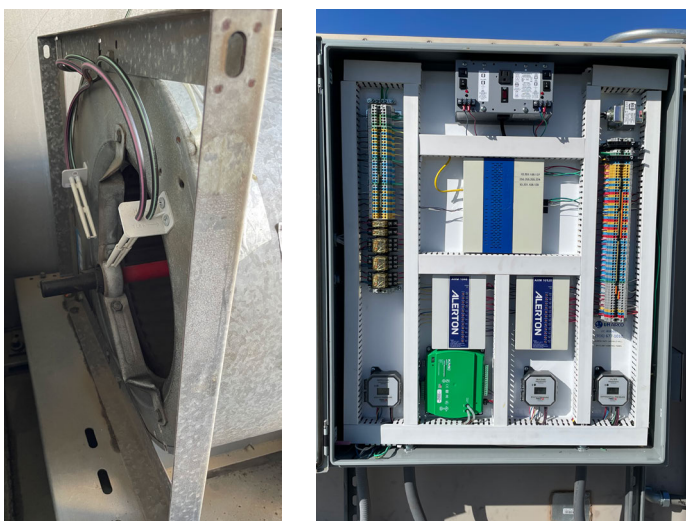
Left: Airflow probes were installed on supply fans when needed. Right: The AFMS (green) installed in a panel.
